DRAINAGE STUDY

PRELIMINARY ENGINEERING ASSESSMENT HIDDEN LAKE ASSOCIATION HADDAM, CONNECTICUT

HRP Associates, Inc.
Engineering & Geology
167 New Britain Avenue
Plainville, Connecticut 06062
Telephone: (860) 793-6899
Fax: (860) 793-6871

June 18, 2002

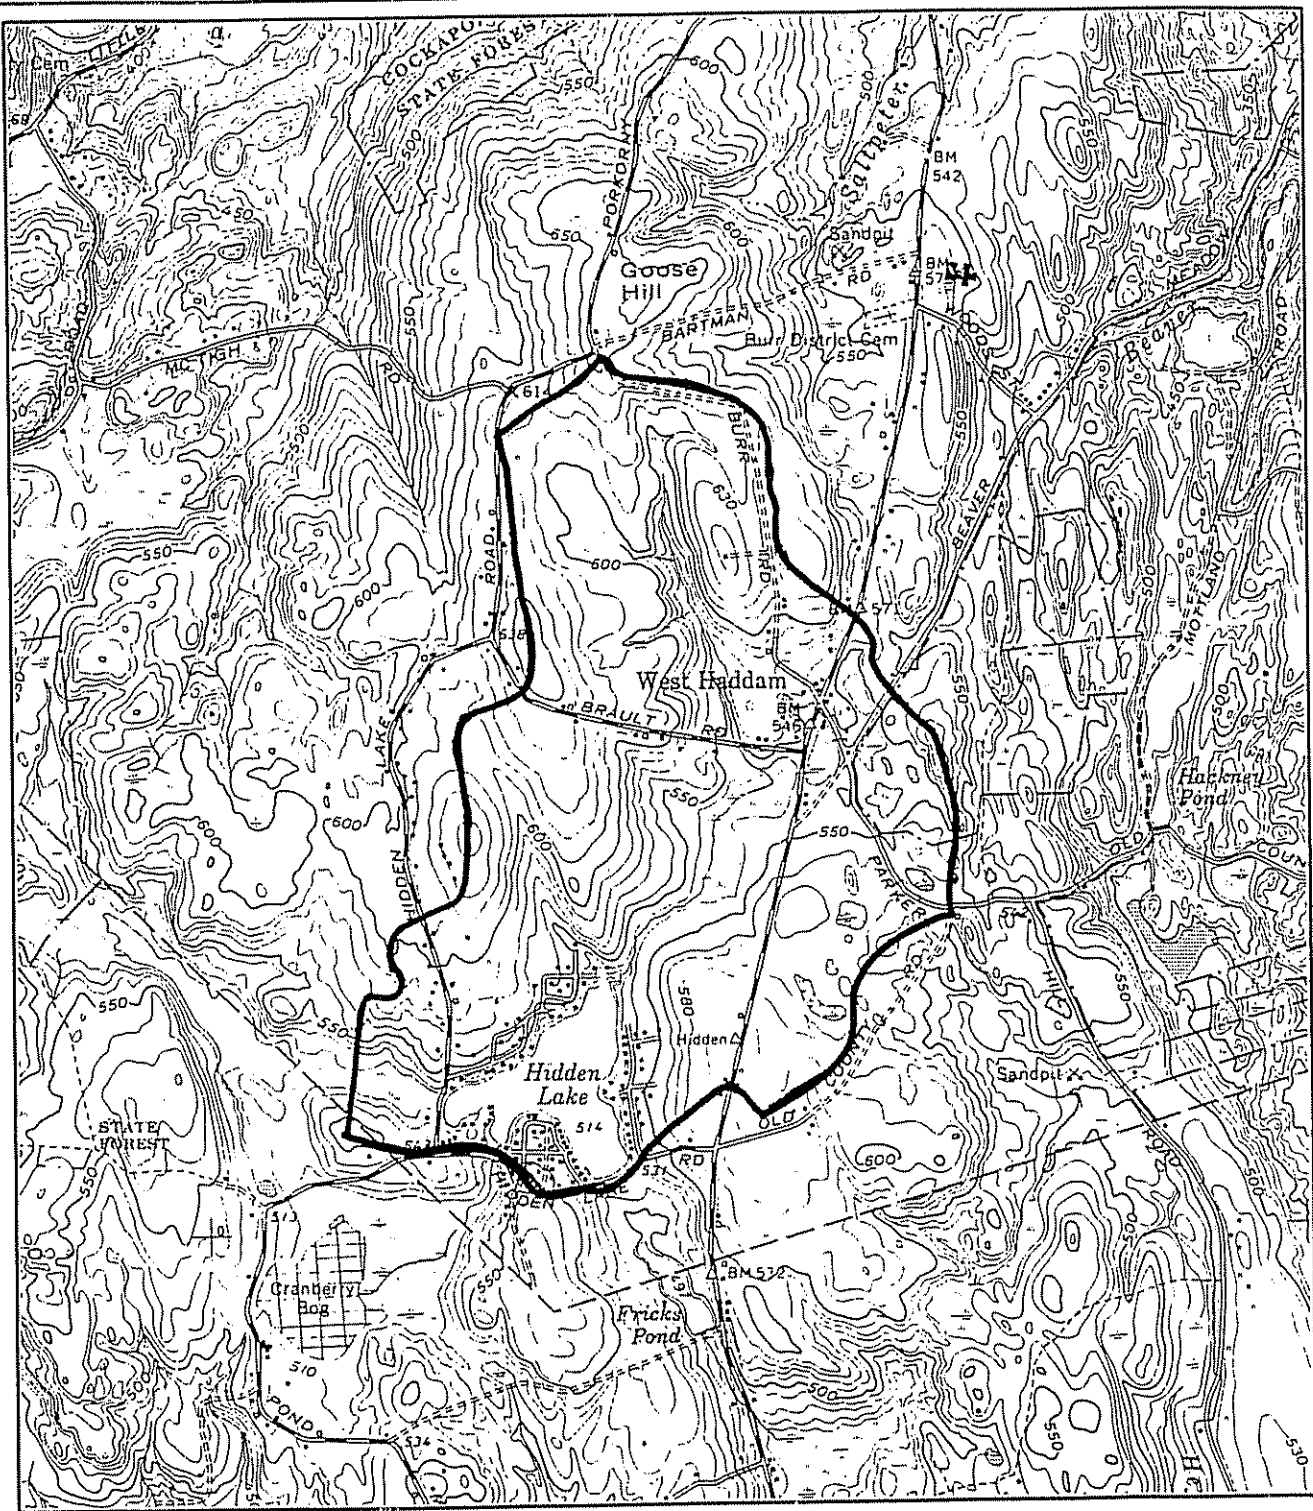
FIGURE 1
HIDDEN LAKE WATERSHED

U.S.G.S. Topographical Map
 Haddam Quadrangle

According to the UCONN Map and Geographic Information Center, Hidden Lake is the receptor of stormwater runoff from a 1.183 square mile watershed area. The watershed area defines an area delineated according to topographic features such as roadways and elevated land that affects the path of rainfall. This particular area is shown on the attached Figure 1. In order to avoid redundancy, reference is made to the 1995 Ecological Study prepared by Priscilla W. Baillie, which provides a detailed description of the flow patterns of the lake.

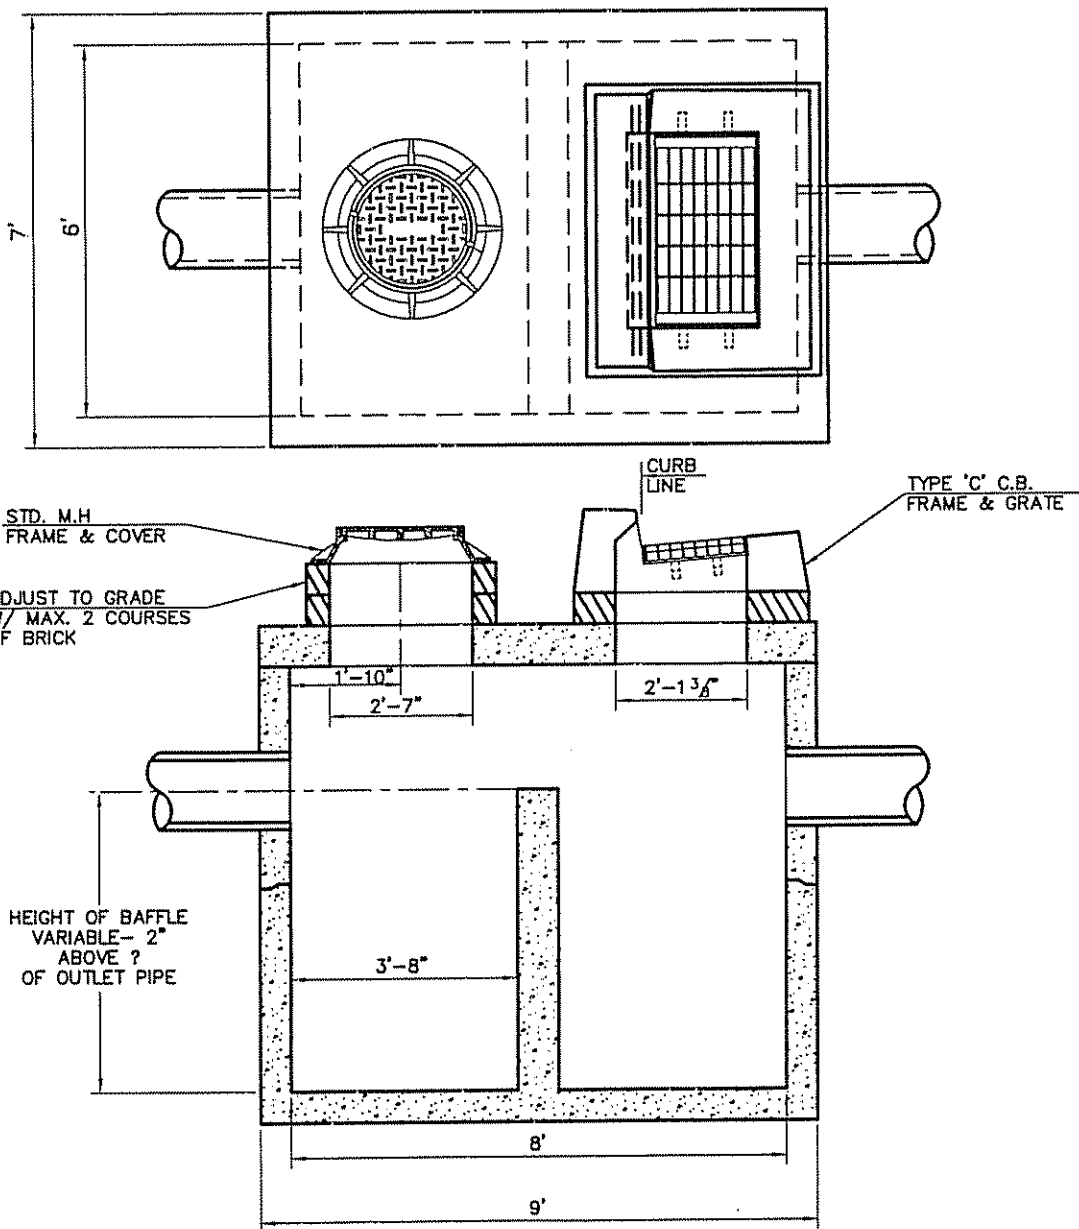
SEDIMENTATION STRUCTURE

N.T.S.

At this location there is an existing drainage system, and flooding only at certain isolated locations. HRP recommends that this drainage system be cleaned to remove any sediments and leaves and to improve all discharge locations by placing properly sized riprap to prevent erosion. Although it is not an urgent area for improvement, future plans should include replacing the drainage structures with three-foot sump catch basins and/or use of a sedimentation chamber prior to discharge into the lake.

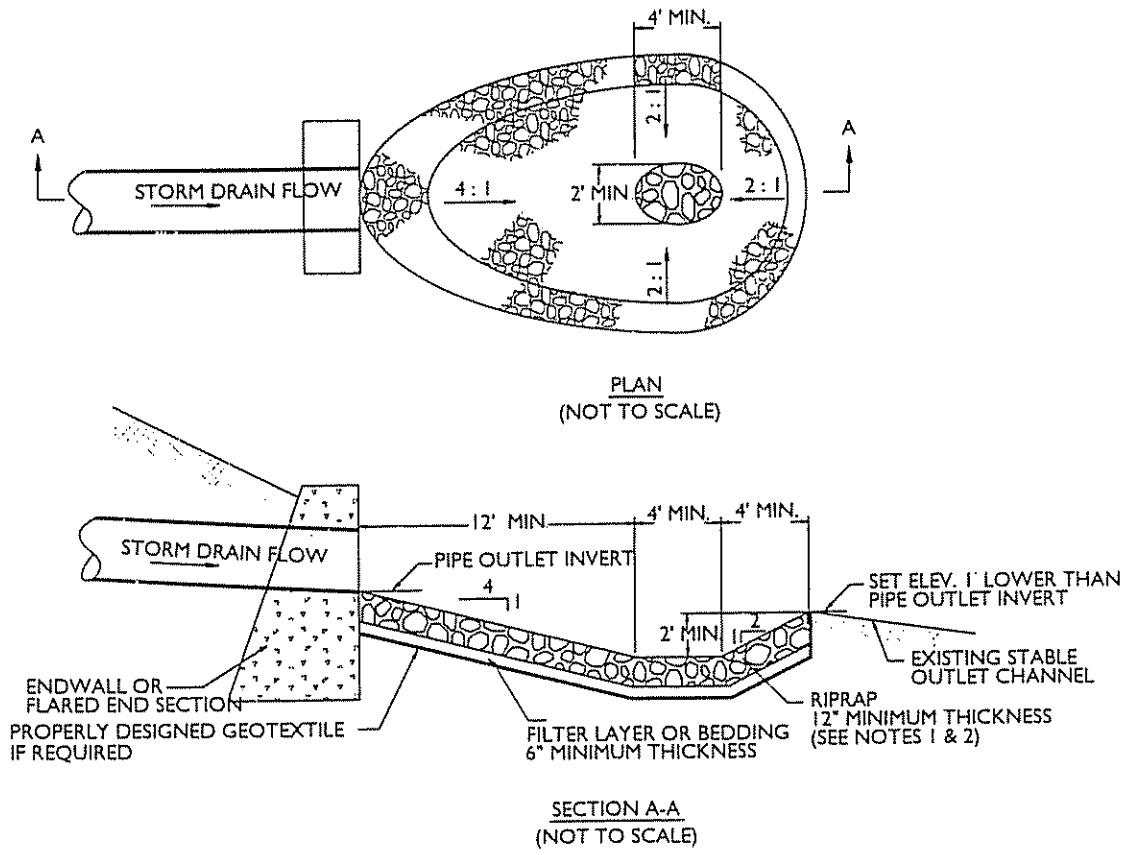
Figure OP-3 Configuration of Outlet Protection using a Riprap Stilling Basin

1. RIPRAP SIZE AND THICKNESS SHALL BE ADJUSTED UPWARD AS THE STORM DRAIN SIZE AND OUTLET VELOCITY INCREASE. SEE PLANNING CONSIDERATIONS SECTION FOR DESIGN REFERENCES.
2. CONSIDER THE APPLICATION OF CEMENTIOUS GROUT IN THE RIPRAP TO PREVENT VANDALISM AND FACILITATE SEDIMENT AND DEBRIS CLEANOUT.

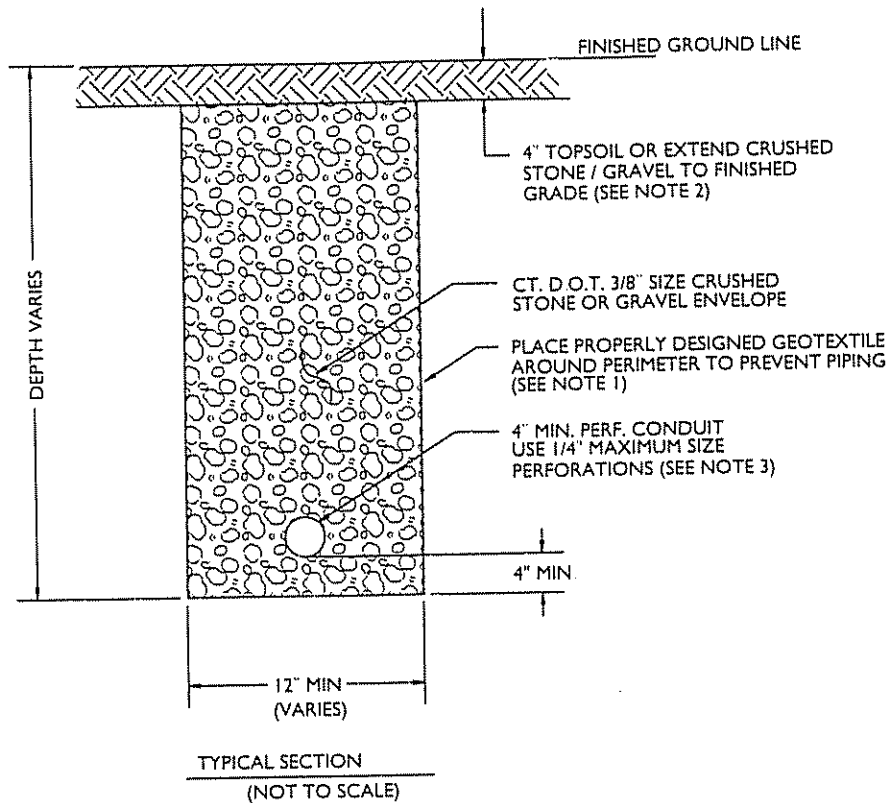
**Figure SD-12. Subsurface Drain with Geotextile
(Soils with Intermediate to High Piping Potential)**

- 1 THE SELECTED GEOTEXTILE SHALL BE DESIGNED SPECIFICALLY TO PREVENT PIPING OF ADJACENT SOILS INTO THE COARSE AGGREGATE
- 2 IF SURFACE WATER IS TO BE INTERCEPTED, EXTEND COARSE AGGREGATE TO THE GROUND SURFACE
- 3 CONDUIT MAY BE HEAVY DUTY PERFORATED HIGH DENSITY POLYETHYLENE OR SPECIALLY DRILLED P.V.C.

In Area 1 problems are occurring from individual pipe systems that may be clogged or of inadequate size. Also, discharge to the lake is occurring at several different drainage swales, which promotes silt migration at multiple locations. HRP recommends that an engineered system be designed to replace the existing system of non-connected pipes. The new system could be situated along East Shore Drive, and route storm-water to one or more catch basins and discharge points. Discharge locations could be lined with riprap to prevent scour. In order to decrease the discharge of sediments, catch basins with three-foot sumps and/or a sedimentation chamber could be designed. Also, installation of a subsurface drain with a protected perforated pipe is suggested to eliminate the ponding along the roadway.
